Manhole Inspection Summary

Manhole # S29G__062MH

Insp Date: **4/1/09 11:22 AM**

Location Address: **801 BOOTH ST**

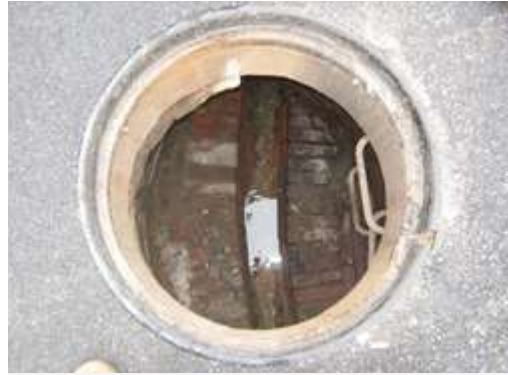
Defect 3

Frame Offset: **0** (in.) Condition: ☐ Sound ☒ **Cracked** ☐ Leaks

cracked frame

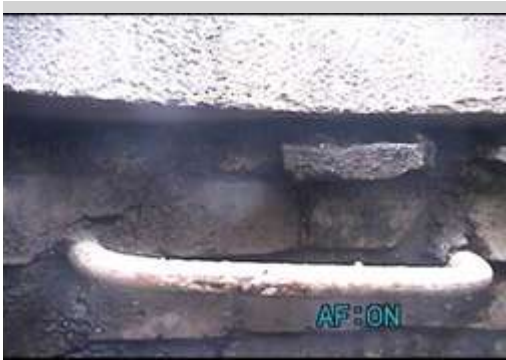
Defect 2

Condition: ☐ Sound ☐ Cracked ☐ Root Intrusion ☒ **Loose Brick** ☐ Deteriorated

LOOSE BRICK

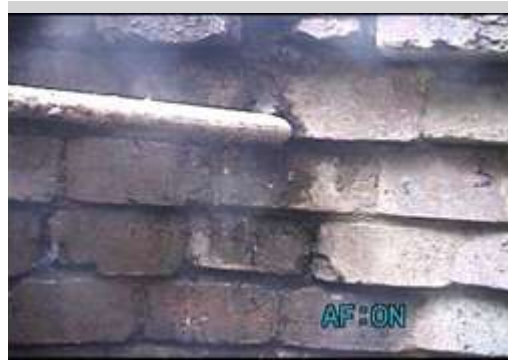
Defect 1

Infiltration: ☐ None ☒ **Joint** ☐ Cracks ☐ Mortar ☐ Roots ☐ Wall

CHIMNEY/FRAME JOINT INFILTRATION

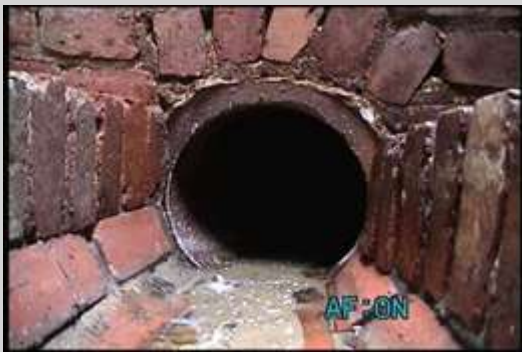
12 O'Clock Outflow

8 in. Circular Gravity Sewer
Pipe Out @ 12 O'Clock

Pipe Height: **8.4** (in.) Rod and Bar (Angled)
Pipe Material: **Clay** ☐ Pipe Lined
Invert Depth: **5.50** (ft.) Flow Characteristics: **Slow**
Deposits: ☒ None ☐ Mud ☐ Sludge ☐ Debris ☐ Grease
Silt Depth: **0** (in.) Deposits Extent:
Infiltration: **None** Pipe Seal Cond: **Sound**

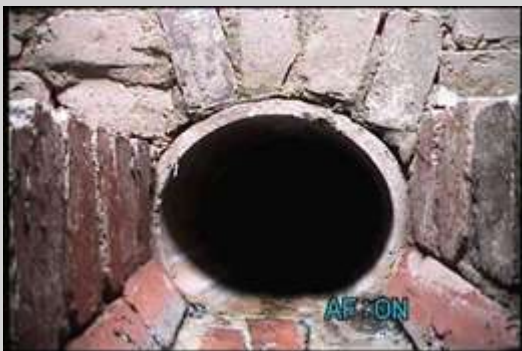
6 O'Clock Inflow

8 in. Circular Gravity Sewer
Pipe In @ 6 O'Clock

Pipe Height: **8.4** (in.) Rod and Bar (Angled)
Pipe Material: **Clay** ☐ Pipe Lined
Invert Depth: **5.44** (ft.) Flow Characteristics: **Slow**
Deposits: ☒ None ☐ Mud ☐ Sludge ☐ Debris ☐ Grease
Silt Depth: **0** (in.) Deposits Extent:
Infiltration: **None** Pipe Seal Cond: **Sound**
